Navajo Abandoned Uranium Mine

Site Screen Report

Taylor Reid No. 2 AUM Site

January 2011

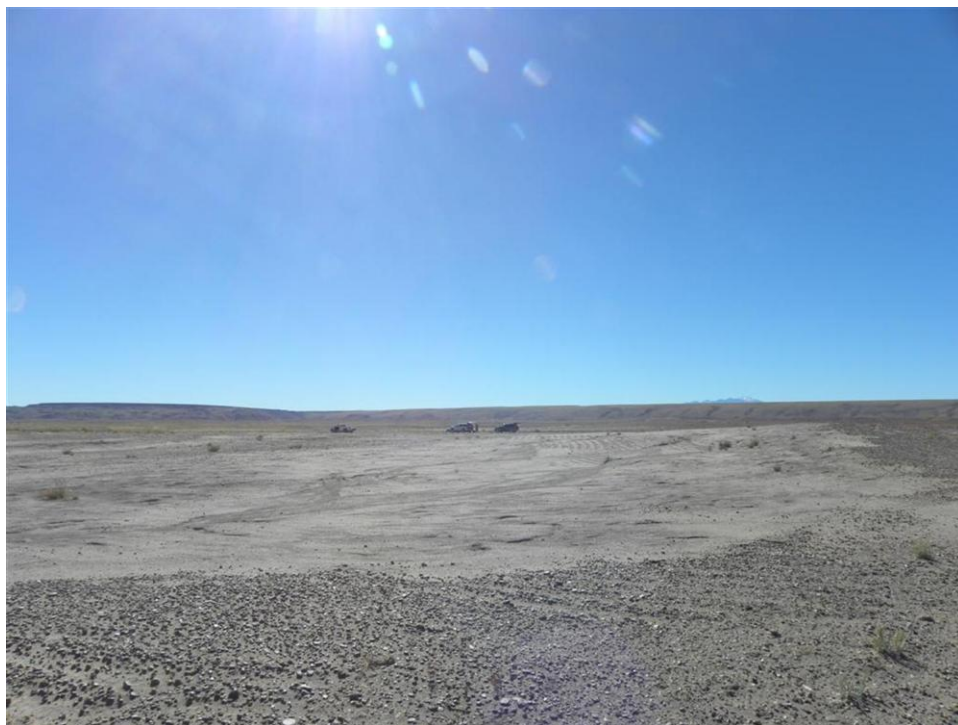
Photo 1. Taylor Reid No. 2 mine site

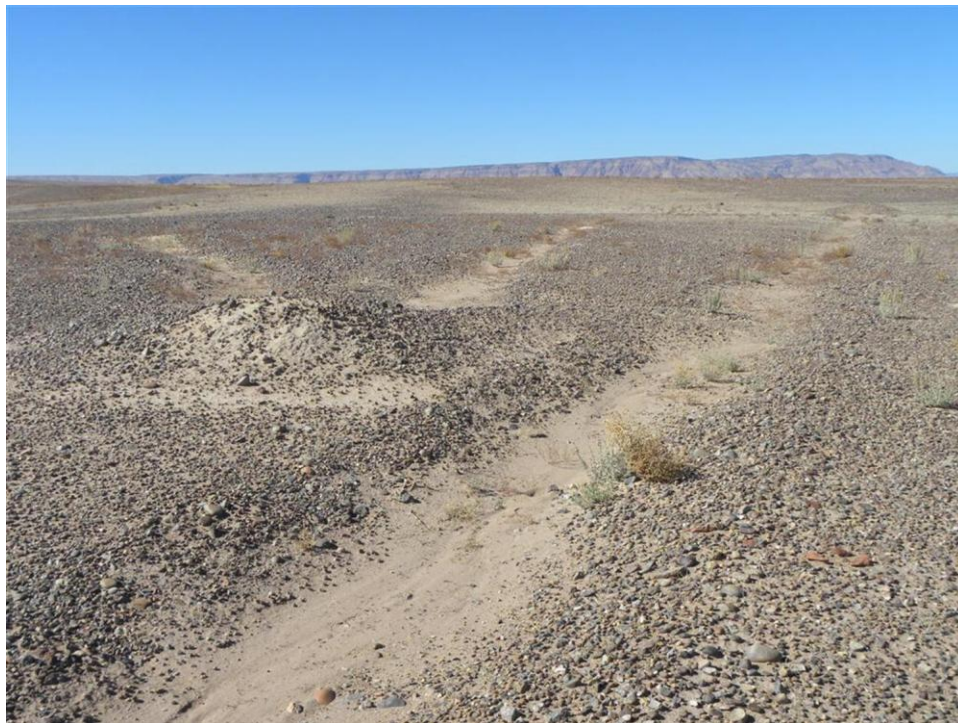
2 waste piles: 1 - 25' diameter x 3' h, within reclamation cap area; 2 - 50' diameter x 5' h

Photo 2. Taylor Reid No. 2 mine site, waste pile

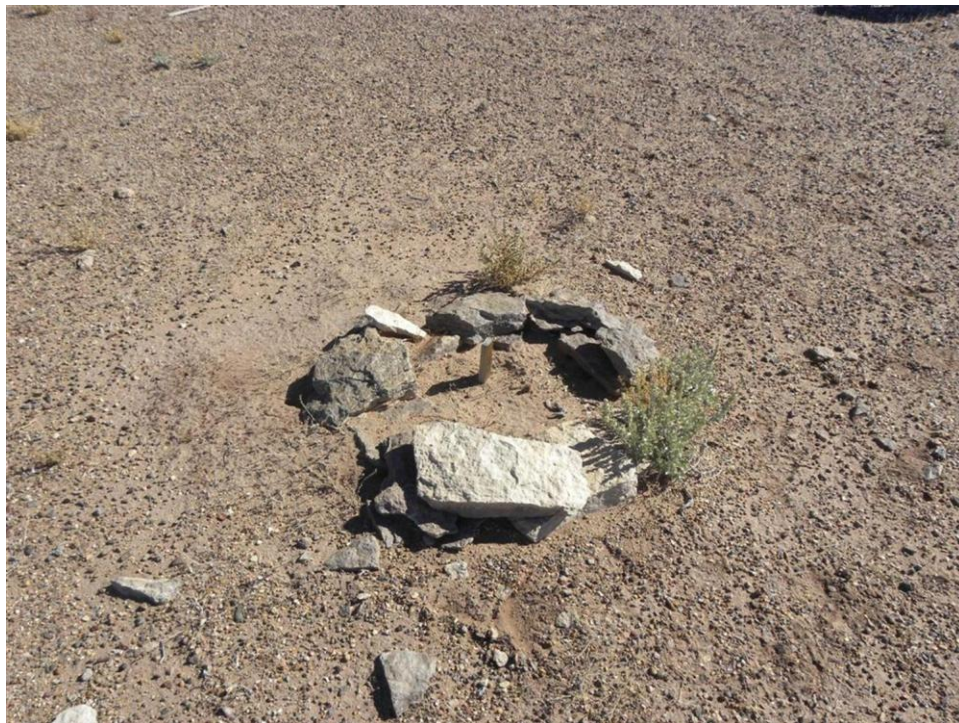
Photo 3. Taylor Reid No. 2 mine site, elevated gamma readings

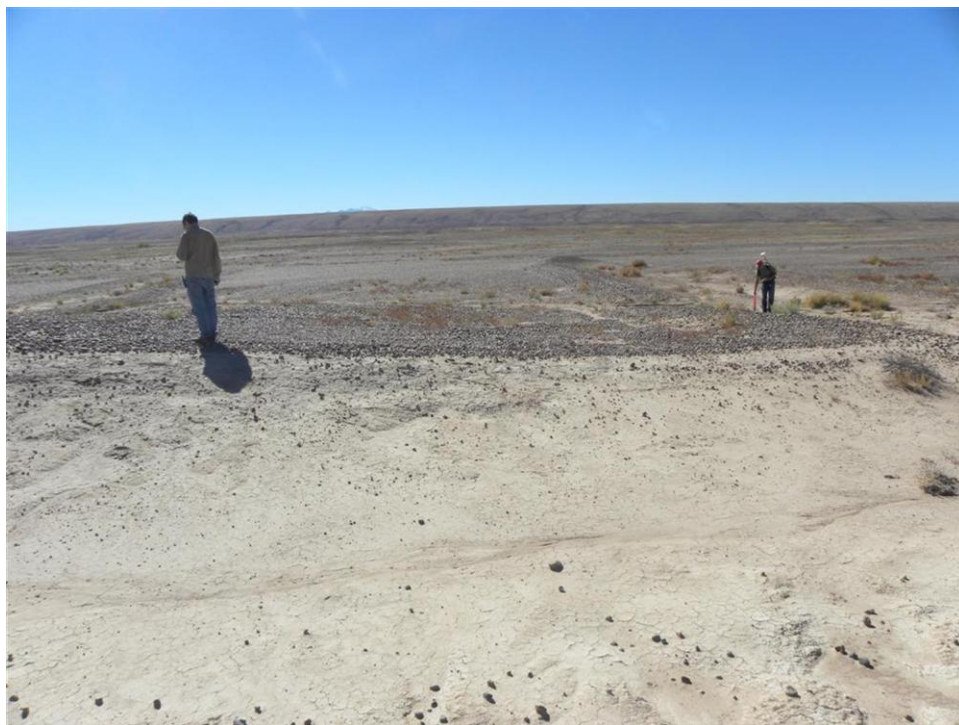
3 reclamation caps: cap 1 - large cap throughout S end of site, red-brown gravel with diversion channels; cap 2 - grey cap N of road with fine soil; cap 3 - small cap / pile with red-brown gravel S of road

Photo 4. Taylor Reid No. 2 mine site, reclamation area

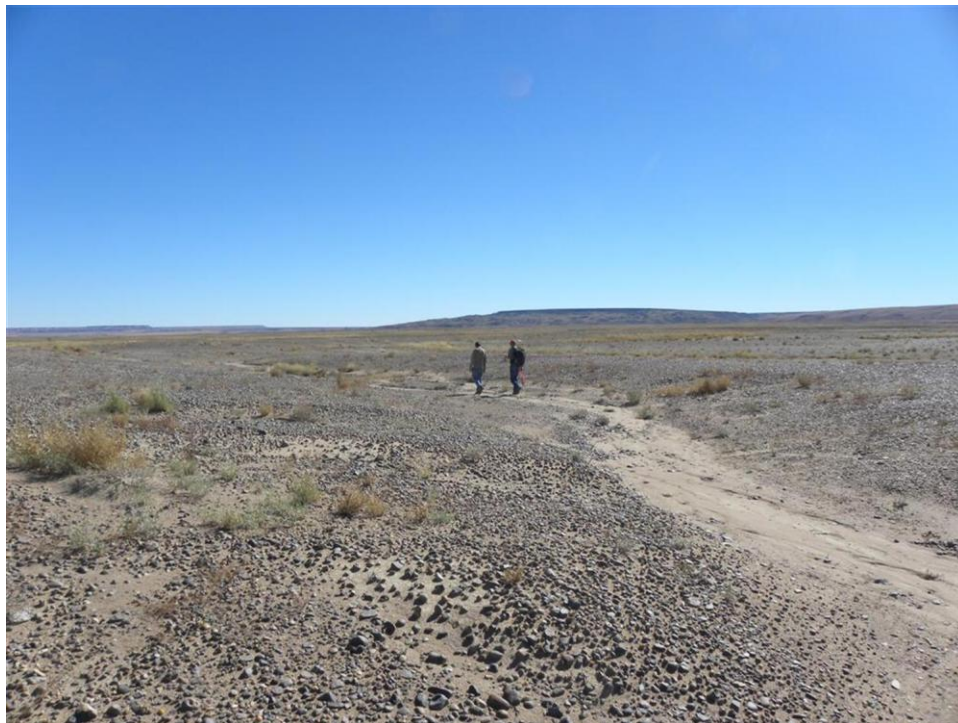
Photo 5. Taylor Reid No. 2 mine site, reclamation area drainage

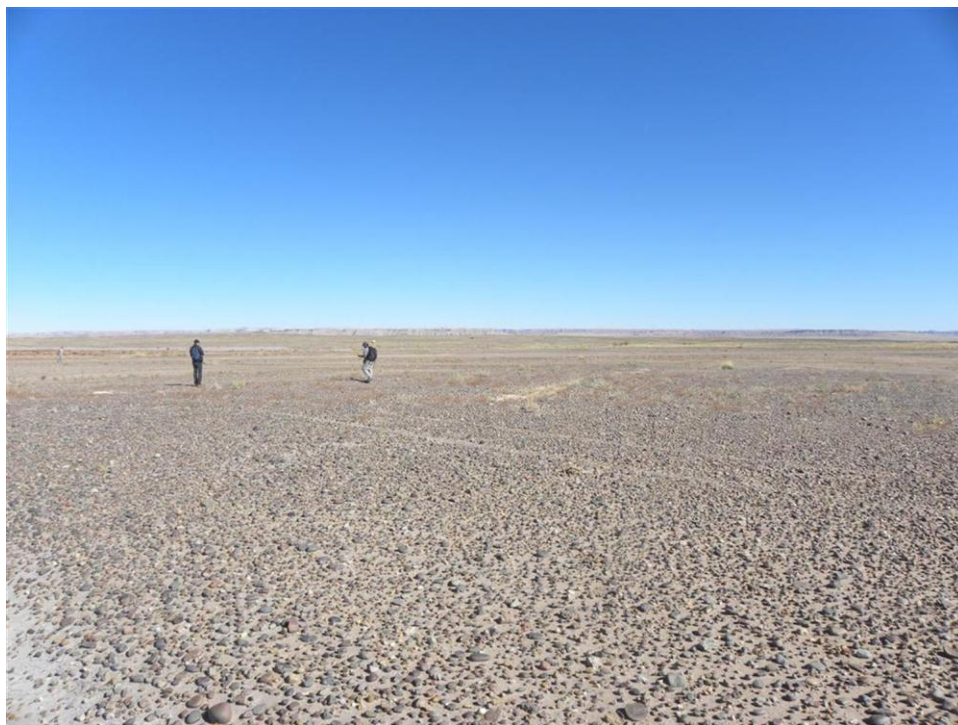
Photo 6. Taylor Reid No. 2 mine site, reclamation area

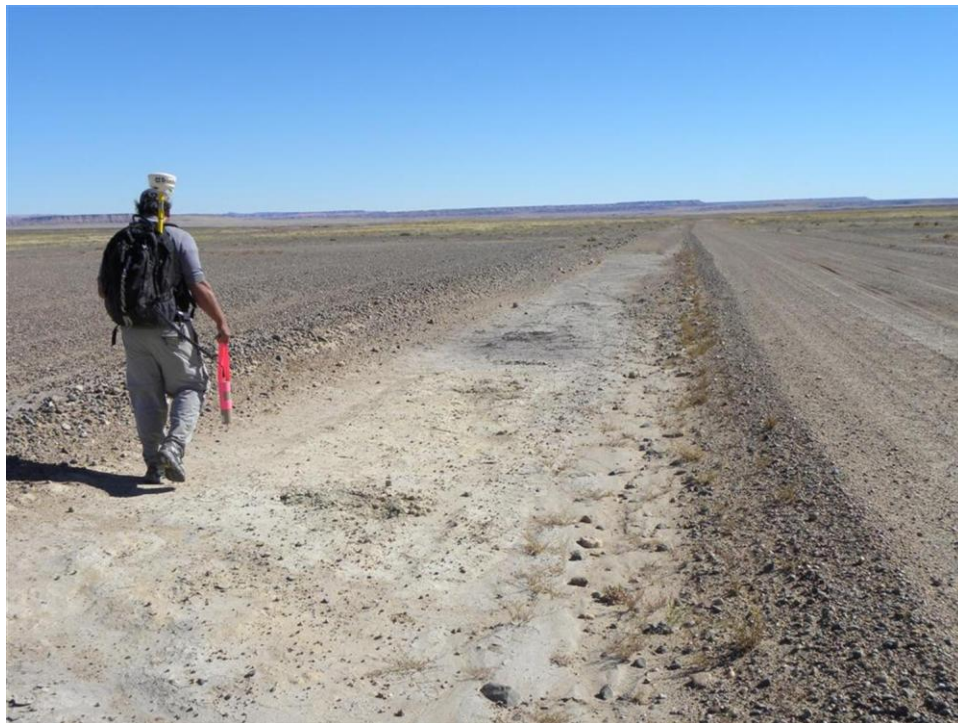
Photo 7. Taylor Reid No. 2 mine site, road
